APOLLO 14 MISSION REPORT

Mission Evaluation Team

April 1971

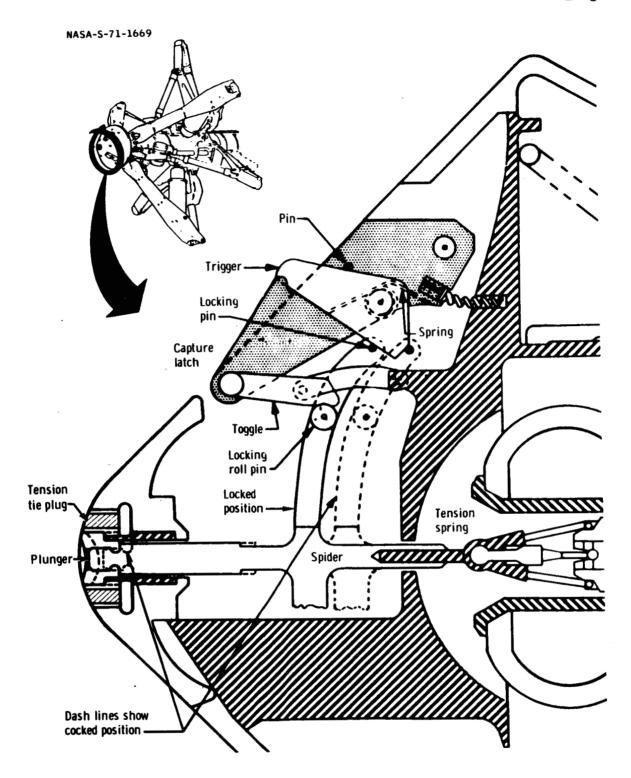
Figure 14-1.- Cross section of probe head and capture-latch assembly.

bestimated velocity from X-thruster activity time. These are maximums with some velocity being used to null out small separation velocity. Other velocities were estimated by film interpretation. The maximum capture-latch response time is 80 milliseconds.

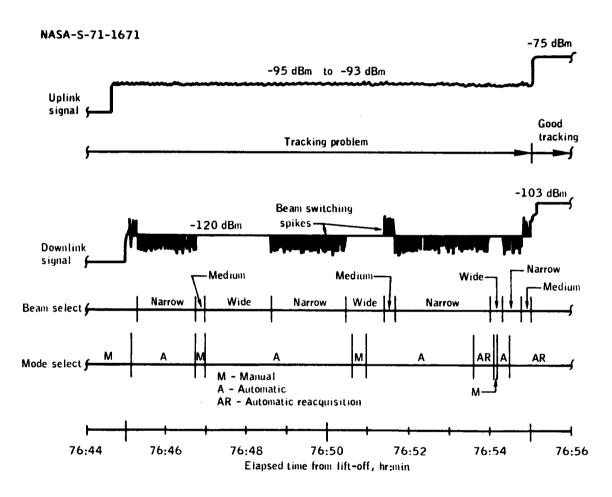
Figure 14-3.- Data from first period of anomalous operation.

The ground data signatures which show the first acquisition and tracking problems are illustrated in figure 14-3. The antenna started tracking a point approximately 5 to 8 degrees off the earth pointing angle at 76:45:00 elapsed time and continued tracking with low uplink and downlink signal levels for 10 minutes at which time a good narrow beam lock-up was achieved.

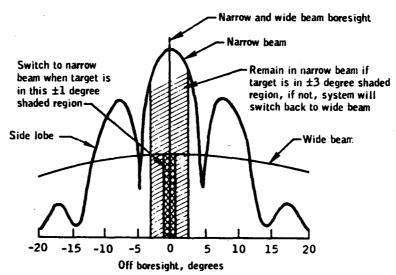
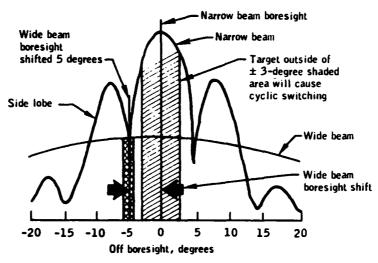
Figure 14-4.- Antenna narrow and wide beam boresight relationship.

The low signals correlate with antenna pattern and gain data for a 5- to 8-degree boresight shift in the wide-beam mode. The direction of the spikes observed on the downlink data in figure 14-3 are consistent with switching between the wide and narrow beams. Conditions for a normal alignment and a misalignment of the wide and narrow beams are shown in figure 14-4. A 5- to 8-degree shift in the wide-beam mode boresight NASA-S-71-1672

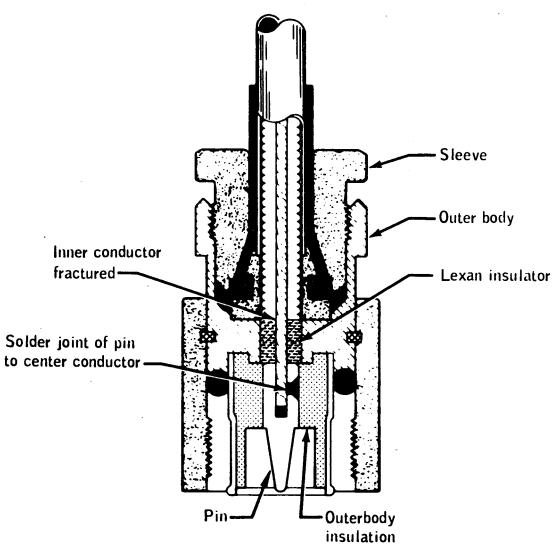
Figure 14-5.- Coaxial cable failures.

Note: A slip fit is required between the pin and insulator so that the pin does not rotate when turning outer body during assembly of the threaded sleeve.

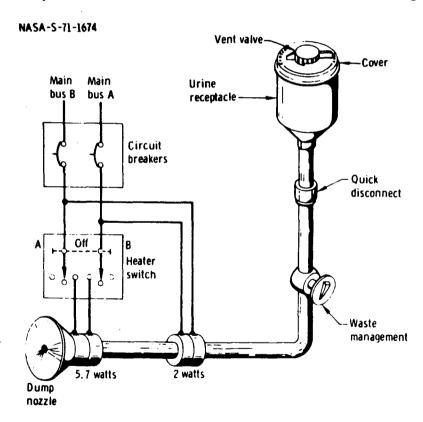
Figure 14-6.- Urine receptacle and nozzle.

After transposition and docking and prior to initiating passive thermal control, the crew indicated that the urine nozzle (fig. 14-6)

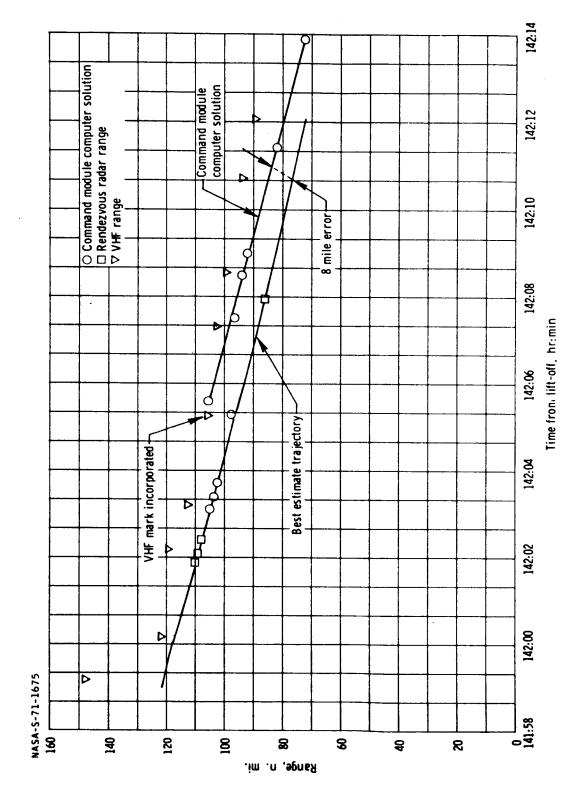
Figure $1^{4}-7$.- Relative range comparisons during rendezvous.

Prior to lunar descent, the VHF ranging and rendezvous radar range measurements correlated closely. However, during the time period preceding terminal phase initiation, the VHF ranging system indicated erroneous measurements. During this same time period, numerous range tracking dropouts also occurred. The range measurements were in error by 5 to 15 miles when compared with the rendezvous radar range measurements (fig. 14-7). The VHF ranging data presented in the figure results from a number of different acquisitions. After terminal phase initiation, the

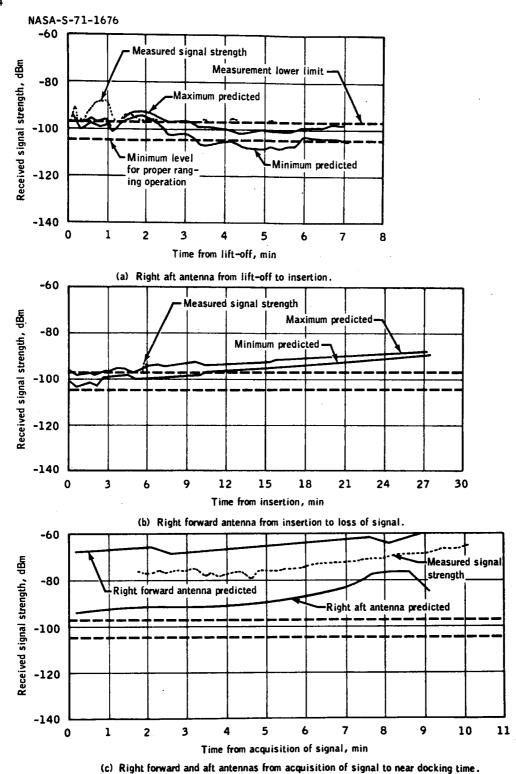
Figure 14-8.- Received signal strength from omnidirectional antennas.

The VHF ranging problems resulted from lower-than-normal signal strength together with the existing range rate. The ranging equipment is designed to operate with signal strengths greater than -105 dBm. The lunar module received signal strength data are essentially qualitative, since most of the inflight data during the problem period were off-scale low. Unfortunately, the scale selection was not chosen for failure analysis. A spot check of relative vehicle attitudes, as evidenced by normal performance of the rendezvous radar and by sextant sightings, indicates that the attitudes were proper. The crew also indicated that they followed the checklist for VHF antenna selection.

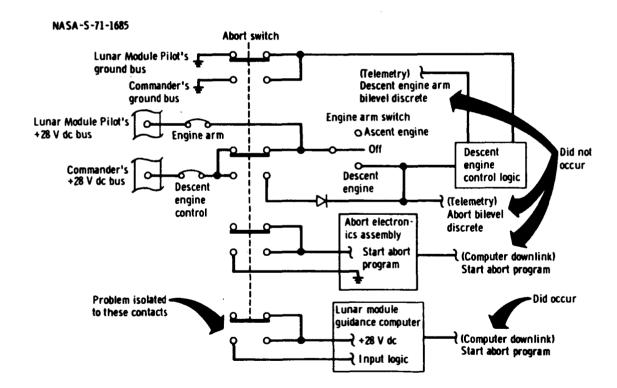
Figure 14-17.- Abort switch logic.

Prior to descent, the primary guidance computer received an abort command four different times. The computer would have reacted if the descent program had been initiated. The failure was isolated to one

- a. The abort stage switch descent-engine override function was removed from the abort-stage circuit breaker and placed on the logic power switch contact. This involved relocating one wire from one switch terminal to another.
- b. Each of the two engine stop switches were rewired so that two series contacts are required to close in order to stop the engine. Formerly, the two sets of contacts in each stop switch were connected in parallel so that closure of either would shut down the engine.

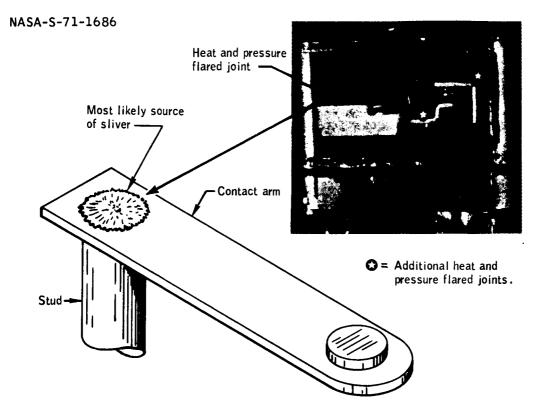
Figure 14-18. - Abort switch contamination.

Metal contamination up to 0.030-inch long slivers found in several switches (a) Simplified sketch of internal switch parts.

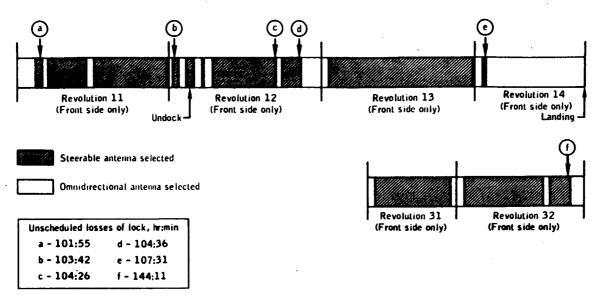
Figure 14-19.- S-band steerable antenna operation.

The remaining unexplained tracking interruptions (fig. 14-19) have similar characteristics. Five tracking interruptions occurred during Goldstone coverage and figure 14-20 is a plot of ground-station-received signal strengths at these times. During the Madrid ground station coverage of revolution 32, another incident was noted with the same type of

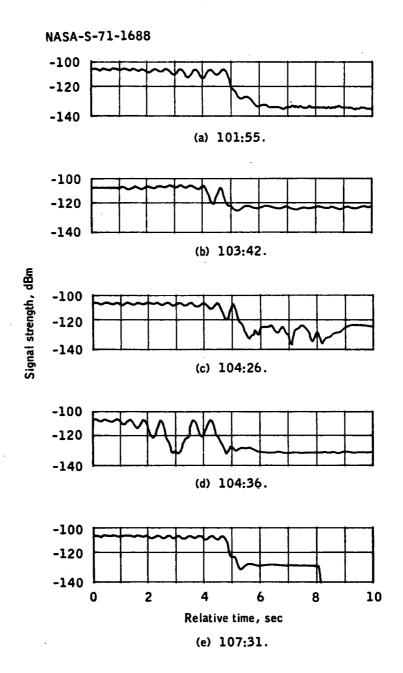
Figure 14-20.- Signal strength oscillations associated with five unexplained losses of lock.

Look-angle data indicate that the antenna was not pointed at or near the vehicle structure during the time periods when antenna lock was lost.

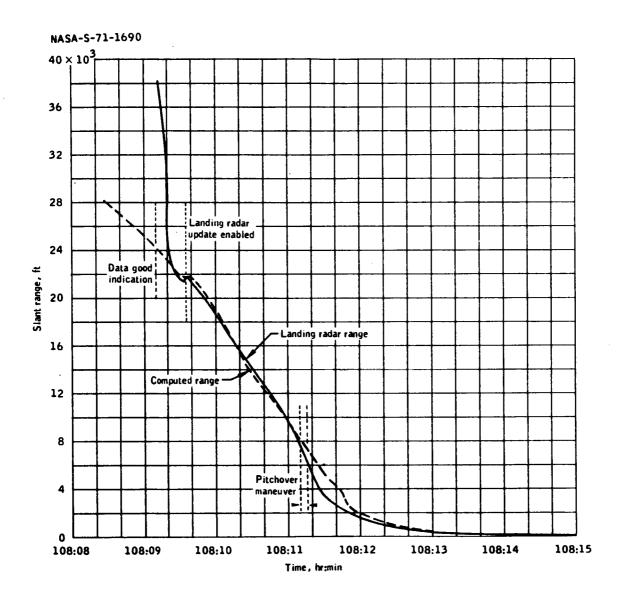
Figure 14-22.- Comparison of measured and computed slant range during powered descent.

The second condition which was not expected occurred after the circuit breaker was recycled. At this time the initial slant range reading was approximately 13 000 feet greater than that calculated from the operational trajectory. Several seconds later, the indicated slant range jumped from 32 000 to 25 000 feet. Subsequently, the landing radar readings compared favorably with the operational trajectory (fig. 14-22).

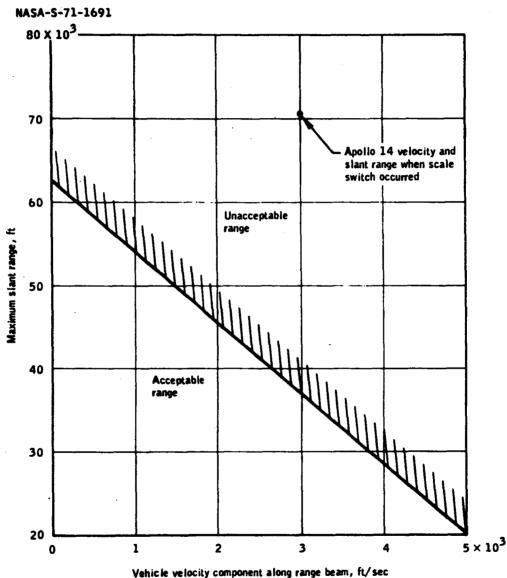
Figure 14-23.- Landing radar range measurement design limitation as a function of vehicle velocity component along range beam.

The scale switching occurred at a slant range of 63 000 feet with a beam 4 velocity of 3000 ft/sec at an incidence angle of 35.4 degrees. Operating the landing radar under these conditions exceeds the maximum range measurement design limit (fig. 14-23). Under these conditions, the receiver is sweeping with maximum gain and the system will be sensitive to any received noise. A test was performed with a radar operating under the Apollo 14 conditions (two range-rate beams locked up and the range beam unlocked). By inserting low-level noise for a fraction of a second into the receiver, range scale switching occurred.

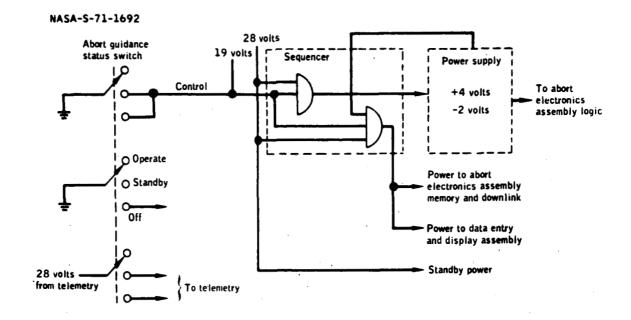
Figure 14-24.- Partial abort guidance system functional diagram.

The system was determined to have been in the standby mode after the failure by comparing expected and actual bus current changes that were observed at the time of the failure and the subsequent cycling of the circuit breakers. Further evidence of the system having been in standby was the absence of the warning light and master alarm at the time of the failure. If standby power in the electronics assembly were not maintained, clock pulses to the abort sensor assembly would have been lost and the warning light would have illuminated and the master alarm sounded. A warning light and a master alarm would also have occurred if the failure had been in the abort guidance status switch or the associated external wiring. These conditions isolate the failure to the power supply section or the sequencer of the abort electronics assembly (fig. 14-24).

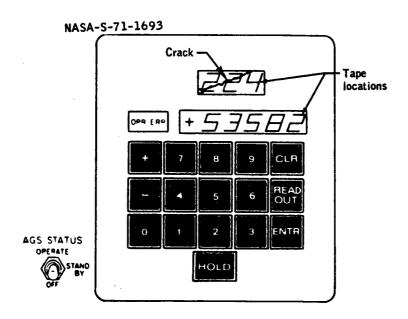
Figure 14-25.- Locations of crack and tape on data entry and display assembly.

The crew reported a crack in the glass across the address register of the data entry and display assembly. Figure 14-25 shows the assembly and the location of the crack. Figure 14-26 is an enlarged drawing of the glass and associated electroluminescent segments.

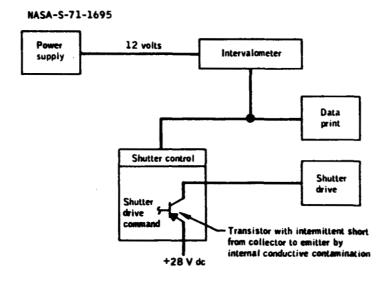
Figure 14-27.- Lunar topographic camera shutter control.

Postflight tests with the flight camera showed satisfactory operation in all simulated environments (pressure, thermal, and vibration) at one-g. An intermittent failure was found in a transistor in the shutter control circuit (fig. 14-27). The transistor was contaminated with a
